St Paulinus Churchyard Treework

This note describes the treework undertaken by the Llangors Community Council between 2022 and 2024.

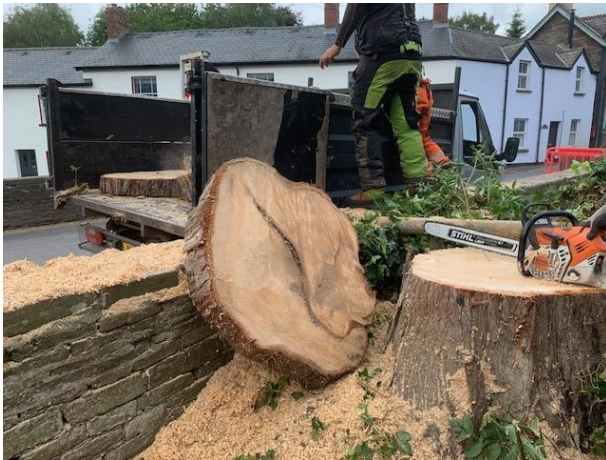
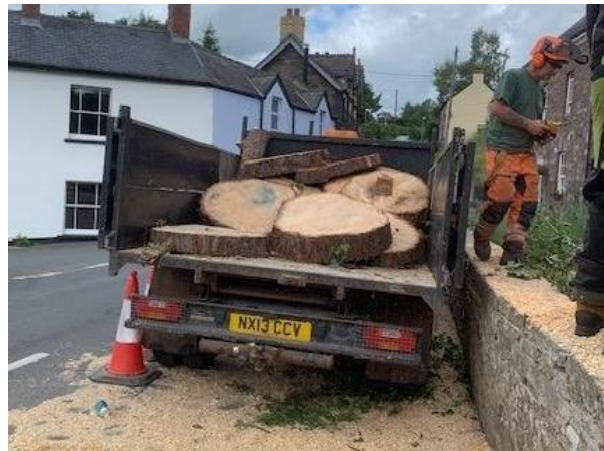
12	Cypress	M	Good. Good vigour. Trunk forks at 4, forming two co-dominant trunks. The fork is narrow, which is not ideal. There are two large wounds on the south side at 5m. There are large lower branches. A cavity may be present.	Further investigation is recommended. This may include a decay assessment and/or felling.	1

Tree 12 was felled in June 2023 and as shown below there was some decay where the trunks forked but this was not sufficient to represent a safety hazard and the main trunk was sound.

The Council consequently decided initially to fell trees 5 and 12 because tree 12 was close to the highway and there had already been a substantial branch fall onto the public footpath and the substantial mass of lower branches on tree 5 appeared to represent a high risk to churchyard users.

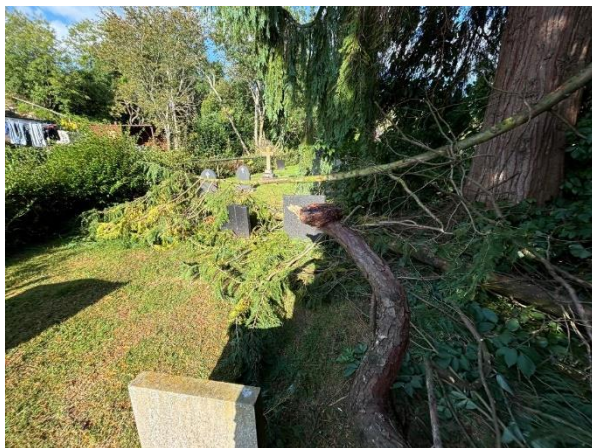
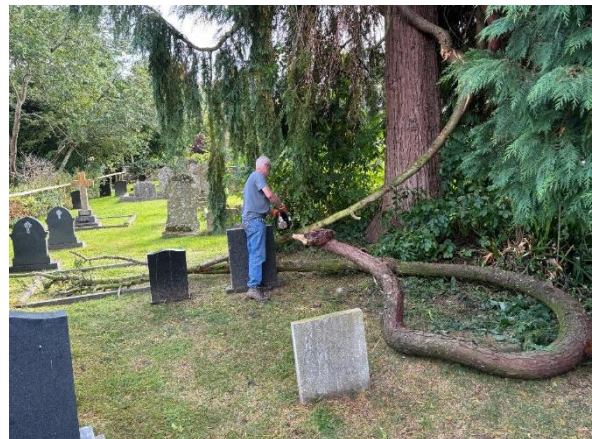
In August 2024 there was a major branch fall from tree 8 as shown below (this risk had not been identified by the inspection).

The Council reacted by engaging OTM to remove all the lower branches and reduce height by a third of both tree 8 and tree 10. This work was completed in November 2023. These remaining trees are regularly inspected by the Councillors responsible for the churchyard for any signs of further potential problems.
